# Barge-Mounted Centrifugal Pumps Eliminate Vortex Issues & Minimize Seepage

An aggregate production company saves more than \$30,000 annually with new installation efficiency and productivity increases.

By James Quillin, Cornell Pump Company

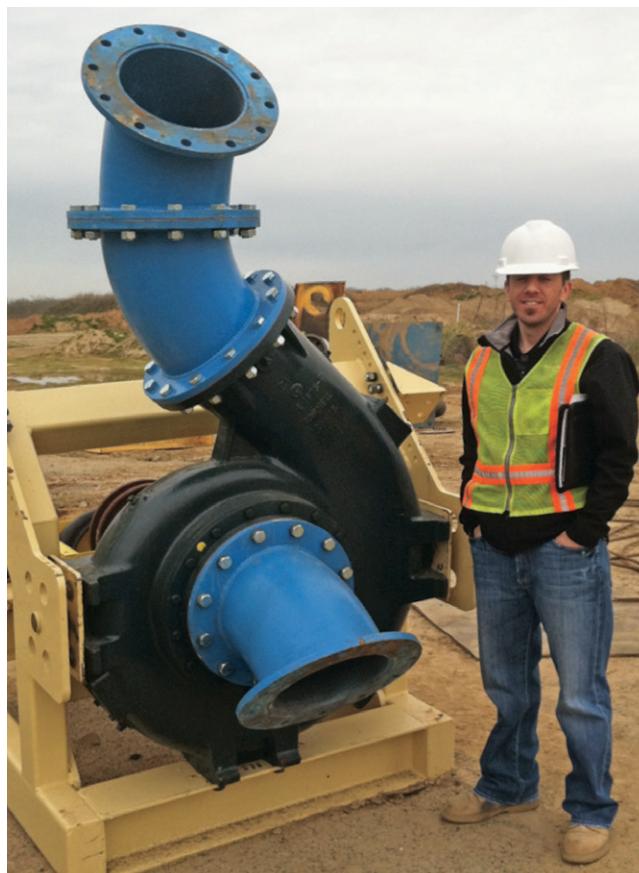
The new dewatering pump

The pumps needed to push up to 18,000 gpm from the pit, and they needed at least 250 feet of head to move the water to the retention/storage area.

in Northern California, even a few percentage points difference added up to a much higher energy bill. The pumps needed to push up to 18,000 gallons per minute (gpm) from the pit, and they needed at least 250 feet of head to move the water to the retention/storage area.

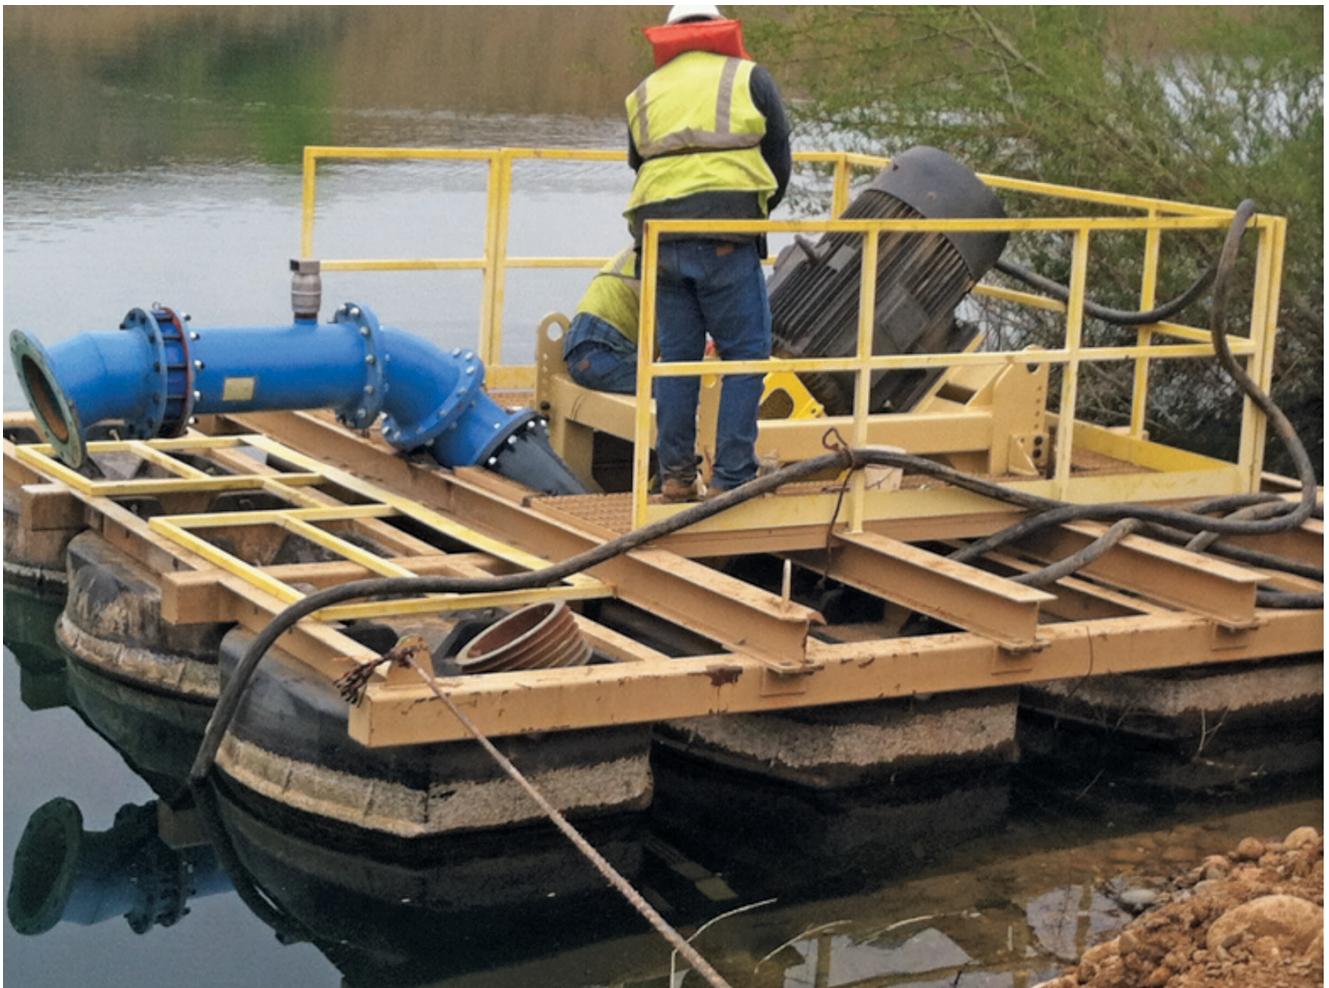
Workers at the aggregate company prepare the newly outfitted barges with the dewatering pumps.

Vortexing can be anticipated in the design phase and eliminated with the proper amount of suction for the water level.

The successful solution was two centrifugal pumps barge-mounted to the bottom of the pit at 45-degree angles. This allowed four advantages:

The pumps were angled at 45 degrees in the water, where the impeller sits partially submerged. This eliminated the need for a priming system. The 45-degree angle also lent itself to a direct-drive power arrangement. The pump distributor wanted to avoid belt drives on the barges because of the issues associated with pulling the barges from the pit for repairs.
