## CLOGGING PUMP STATION NEEDS INNOVATIVE APPROACH

*CORNELL AND PARTNERS TESTED VARIOUS CORNELL CUTTER VARIATIONS TO HELP ALLEVIATE RAGGING; NEW HYBRID CUTTER—AUGER WORKED BEST.*

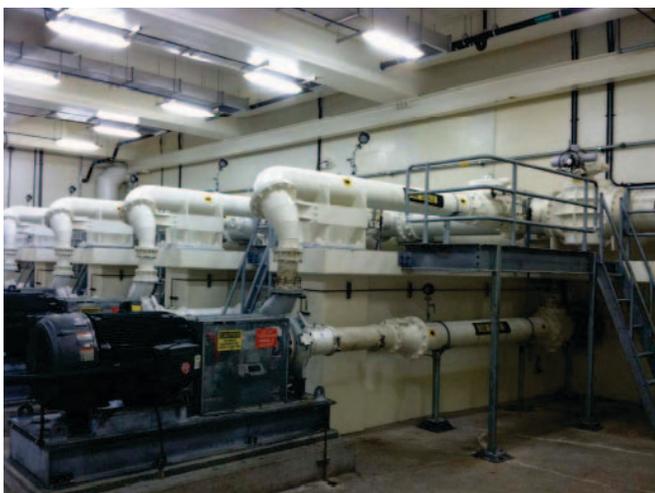
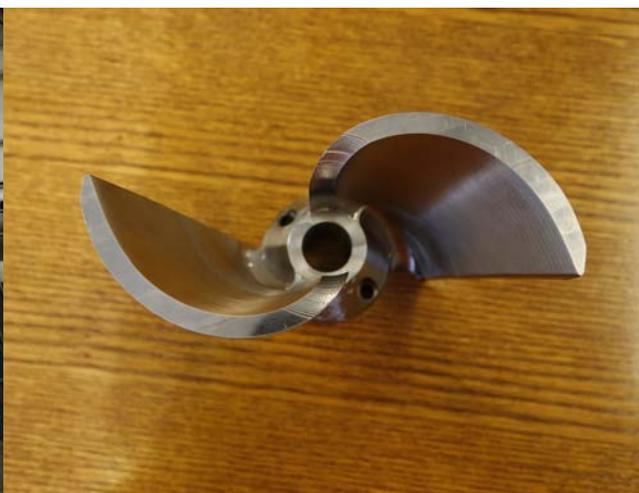
Cornell got to work creating more than half a dozen prototypes designs for new cutters to deal with the plugging of the impeller eye; there was not enough vane geometry to guide the flow of solids into the impeller passageway. Ultimately, the solution was using the stationary cutter from the original cutter system, and adding a hybrid cutter—auger that extended impeller vanes all the way to the center, while using the auger as cutter of the ragging material.

The new cutter—auger design reduced capacity somewhat, but kept a consistent flow rate throughout the day. Ragging events were reduced more than ninety percent. The municipal water district is looking at retrofit other pump stations, in order to reduce ragging events.
